PROBLEM OF THE PERVERSE PINION (A)

*a case history in failure analysis
told from the viewpoint of a consultant*

Charles O. Smith
Professor of Mechanical Engineering
University of Detroit

PROBLEM OF THE PERVERSE PINION (B)

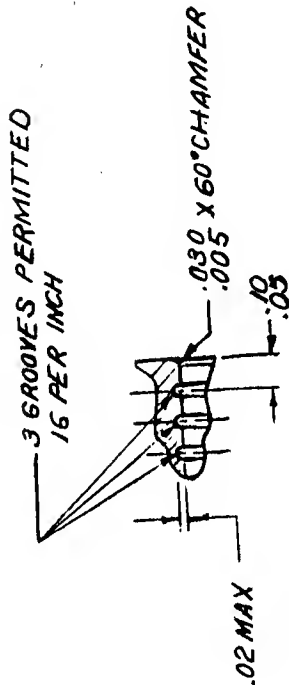
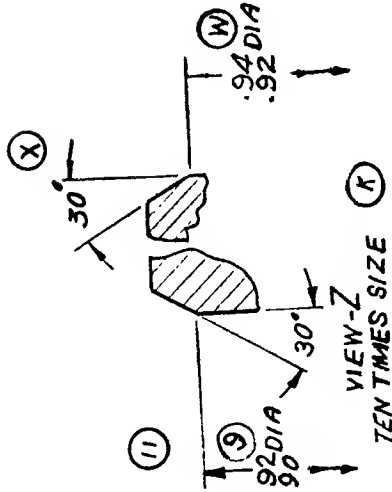
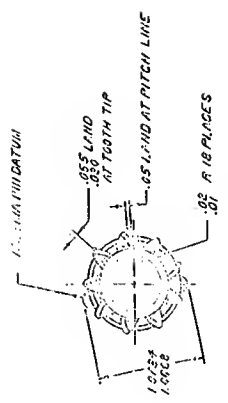
EXHIBIT A-1 PINION WITH NINE TEETH

The dimensional tolerances shown in Exhibit A-1 seem reasonable. One critical dimension is not clearly stated. Observe the situation at the end of the tooth at the base of the surface which is at an angle of 40° to the end of the pinion. It is not obvious that a fillet radius is stated although one could infer that it should be 0.01 to 0.02 in., i.e., the same as the fillet radius at the base of the pinion teeth.

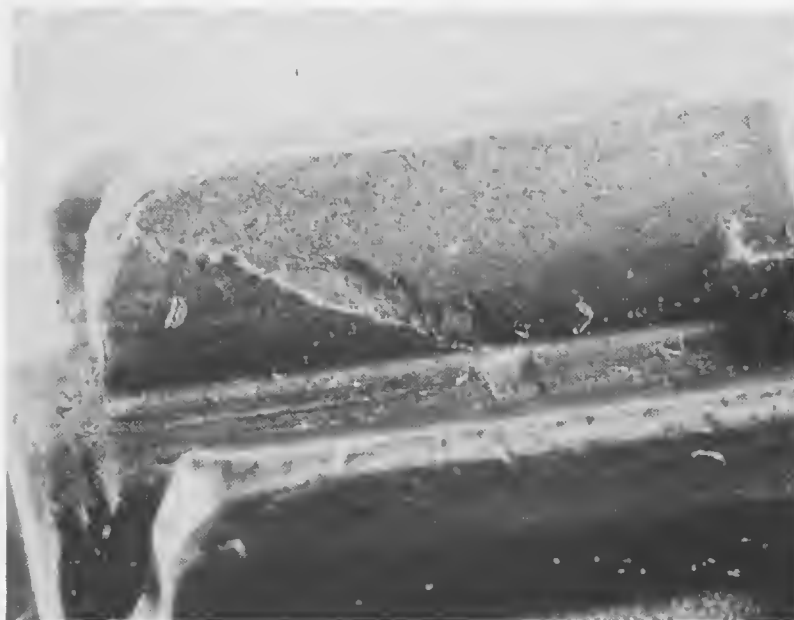
A new pinion.

The tooth in Exhibit A-4 shows an extreme example of a surface imperfection on a tooth of an unused gear. This defect extended across the root surface and up the back side of the neighboring tooth. Two small chips were removed from the defect in the root surface. Magnetic particle inspection of this pinion indicated the presence of sub-surface cracks along the pitch line and at the root of the teeth.

Defect (on drive side of tooth) extends across root surface and up the back side of the tooth in the foreground. Two small chips were removed from the defect at the root surface. Magnetic particle inspection indicated sub-surface cracks along the pitch line and at the fillet at the tooth root. Note general roughness and "strings" of small defects along the top of the surface of the tooth.

While the appearance of the tooth surface in Exhibit A-4 is an extreme example, the general roughness was found on many of the pinions examined, both new and used. This appearance is NOT typical of surfaces which have been cold worked and could be due to small surface seams in the original stock, dirty dies used in forming the teeth, and/or stripping the copper plate.

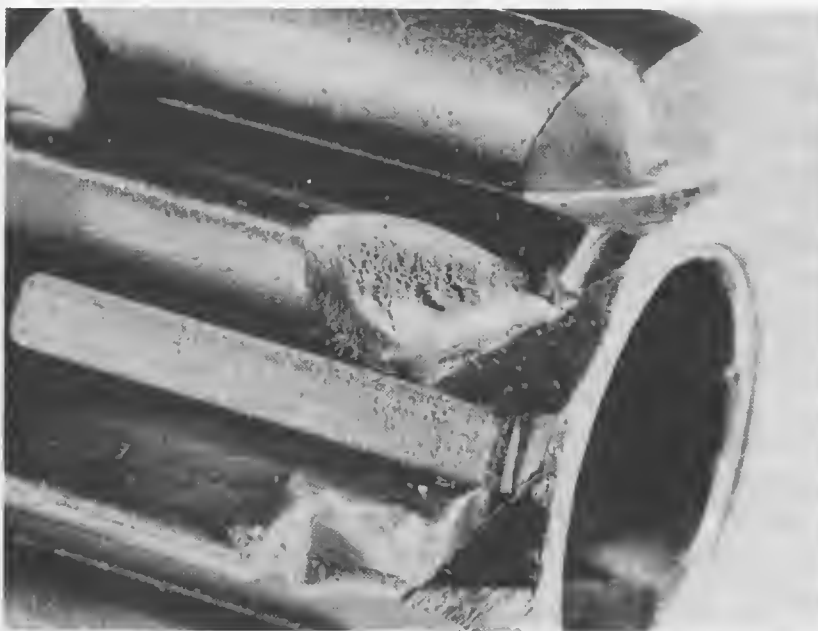
Examination of a number of failed pinions revealed each had one or more teeth with similar failures. A typical one is shown in Exhibit A-5. This tooth was one of three on this pinion which failed in the same apparent manner. The second failed tooth appears in the lower part of Exhibit A-5. The third tooth is below the second

Fracture of a tooth. There is some suggestion of a "woody" macrostructure in the failed surface. Visual examination at 20X with a binocular microscope gives an illusion of an undercut at the fillet.

The failed teeth shown in Exhibits A-5 and A-6 were typical of the failures on

other pinions. These are characteristic fatigue failures. Failure was initiated in the fillet at the root of the machined surface which is at 40° to the end of the pinion. There is a "smooth" portion adjoining this fillet which merges into a "rough" portion of the fracture at some distance from the fillet.

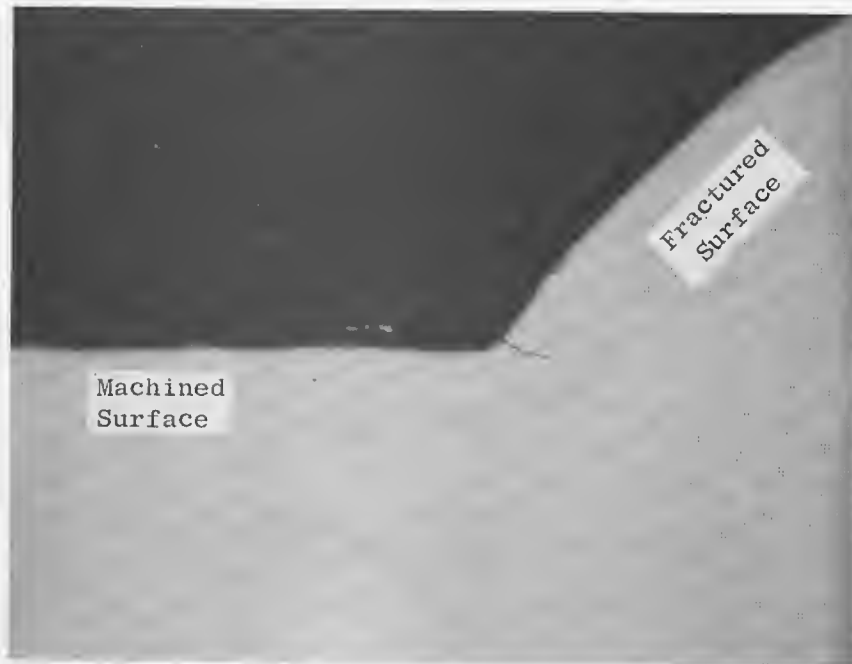
Exhibit B-1 is a section of this failure at the fillet. This is at the location for which the radius is not clearly specified (see comment on Exhibit A-1 above). If we assume that this radius should be the same as at the root of the teeth (0.010 to 0.020 in.), it is obvious that the assumption is not justified in this case since the radius is approximately 0.002 in.

The major factor leading to tooth failure was the high concentration of stress at the root of the surface at 40° to the end of

the pinion. This has several contributory factors: stress concentration from the much-too-small fillet radius; increase in applied load above previous requirement; and probable existence of sub-surface cracks before use.

Section through failed tooth through the 40° surface.
The measured radius of the fillet is approximately
0.002 in. A crack is apparent at the fillet.

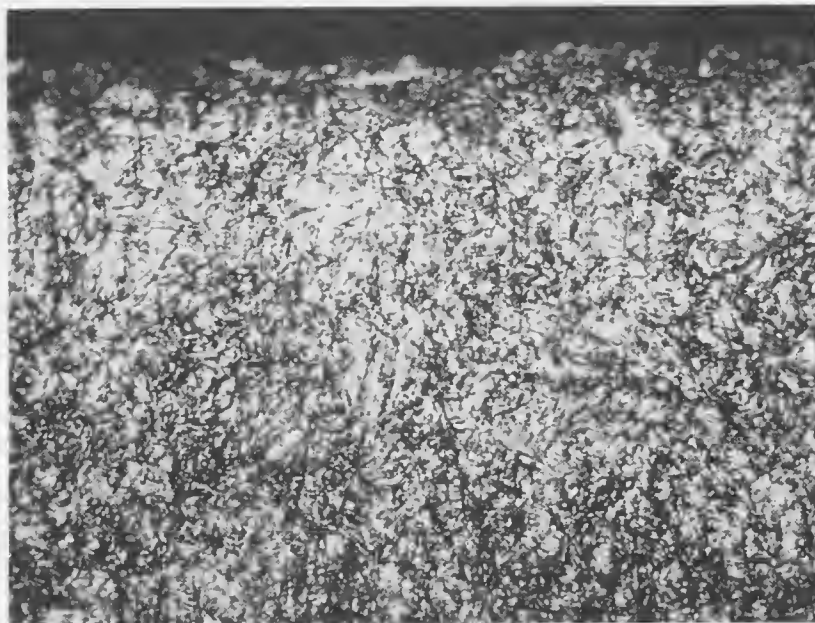
A Rockwell hardness of 80A (equivalent to Rockwell 58C) was measured on the hub. A diamond pyramid hardness of 730 (equivalent to Rockwell 61.50) was found at 0.003 in. below the surface at the pitch line. This is just slightly above the specification of Rockwell 79-82A (56-61C). The total case depth on the tooth is 0.022 in. and is thus within specification limits. Tooth core structure is tempered (low carbon) martensite. The tooth case shows approximately 30-40% retained austenite to a depth of 0.006 in. (Exhibit B-3). This obviously exceeds the specification limit of 10%.

The general appearance of new pinions and failure to meet various specifications (e.g., Exhibit B-3) are, in this case, of secondary consideration although these, in the absence of the primary factor of high stress concentration, would lead to excessive wear and pitting along the wear surfaces. This in turn could result in fracture. These secondary aspects are difficult to reconcile with high quality work in which there has been proper control of processing and proper inspection.

Carburized case on tooth showing 30-40% visible retained austenite to a depth of 0.006 in.
